Subject: Water Testing for Lead

West High School

As requested by the Madison Metropolitan School District (MMSD), TRC Environmental Corporation (TRC) performed testing for lead in water at West High School.

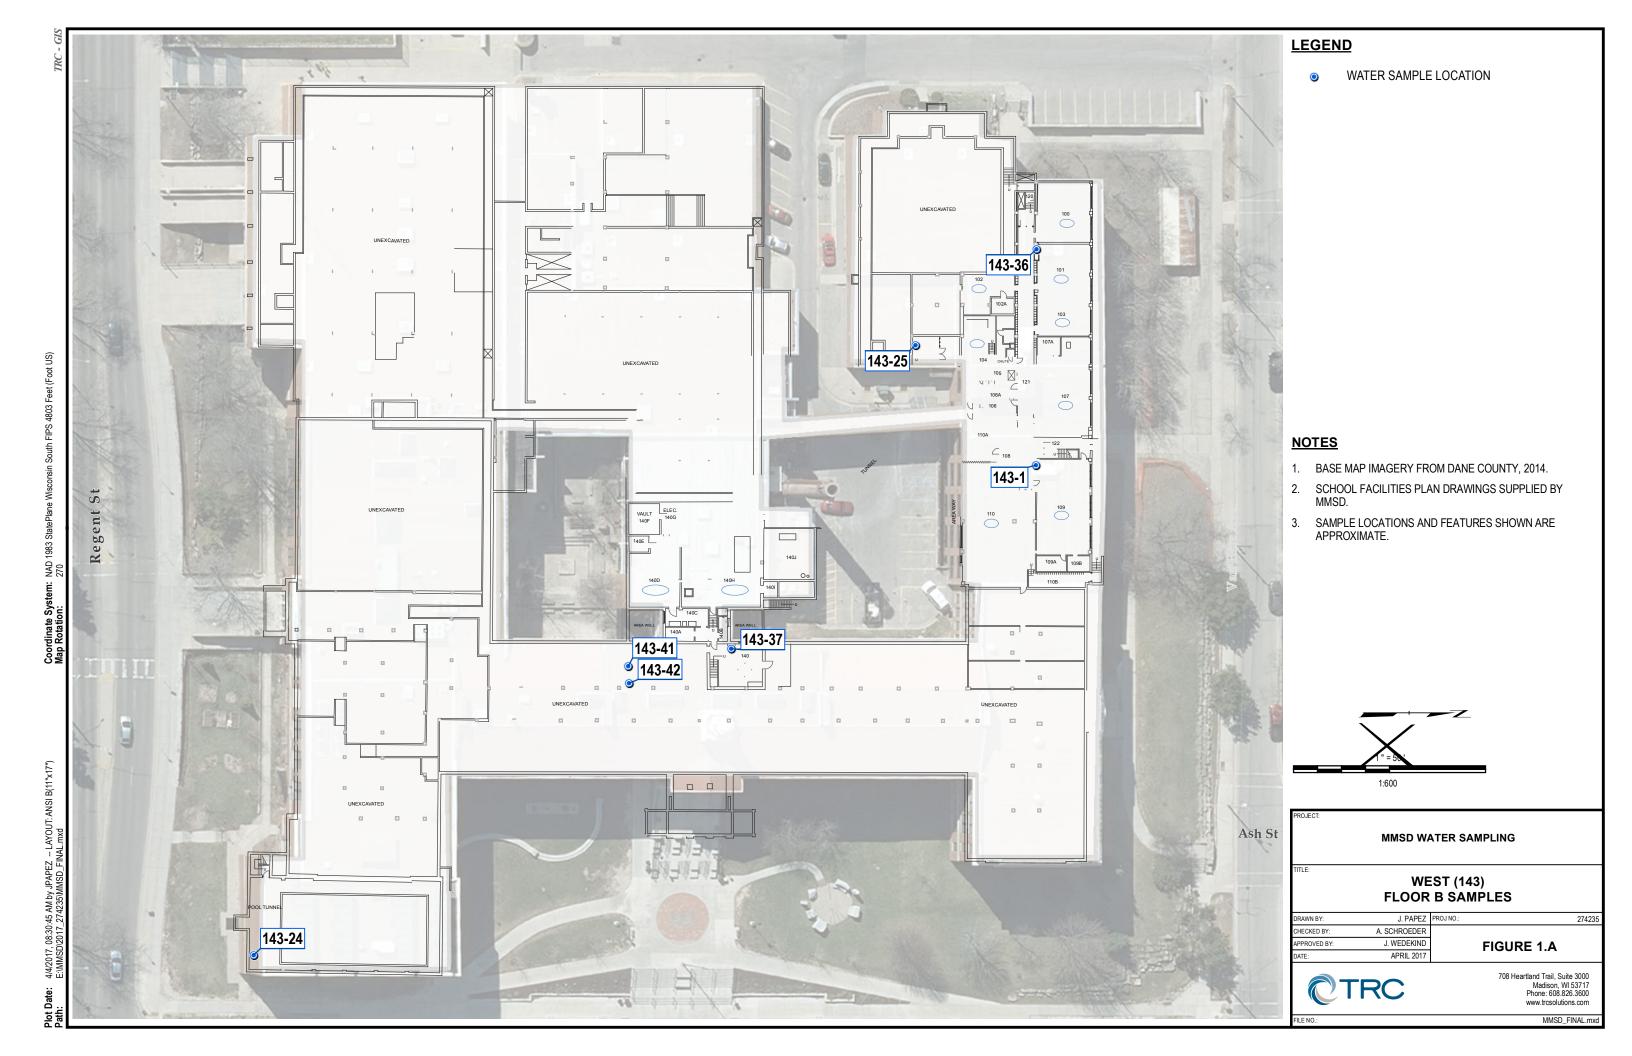
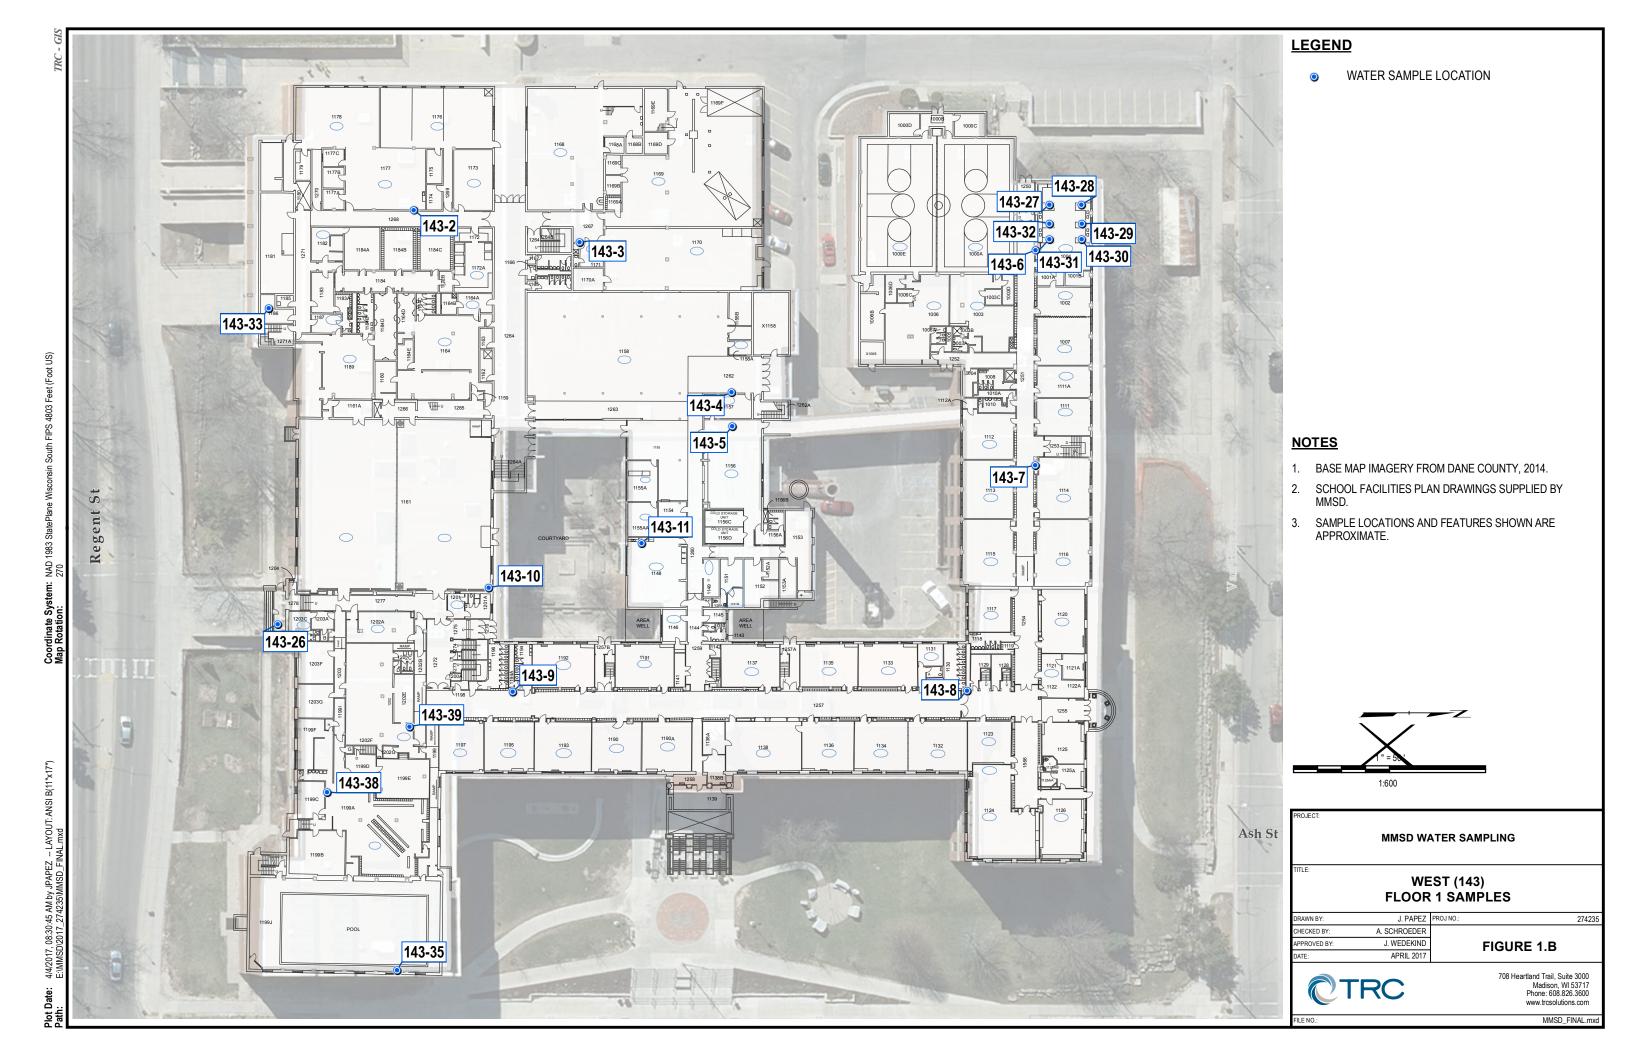
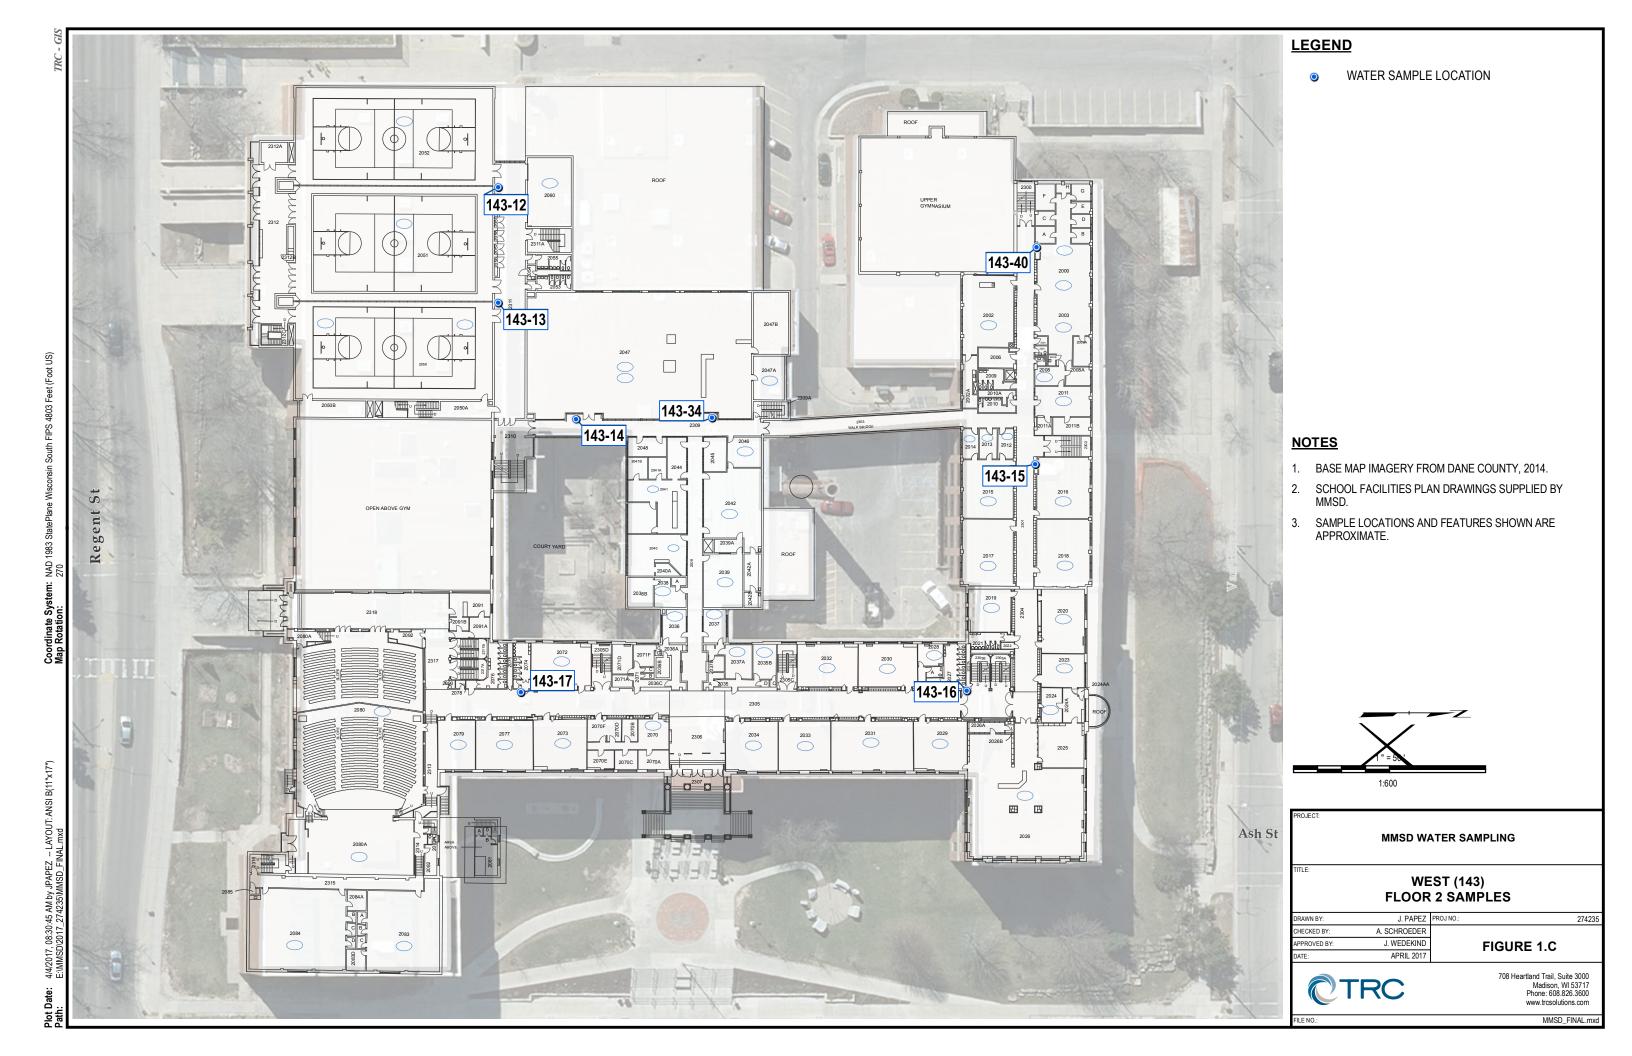
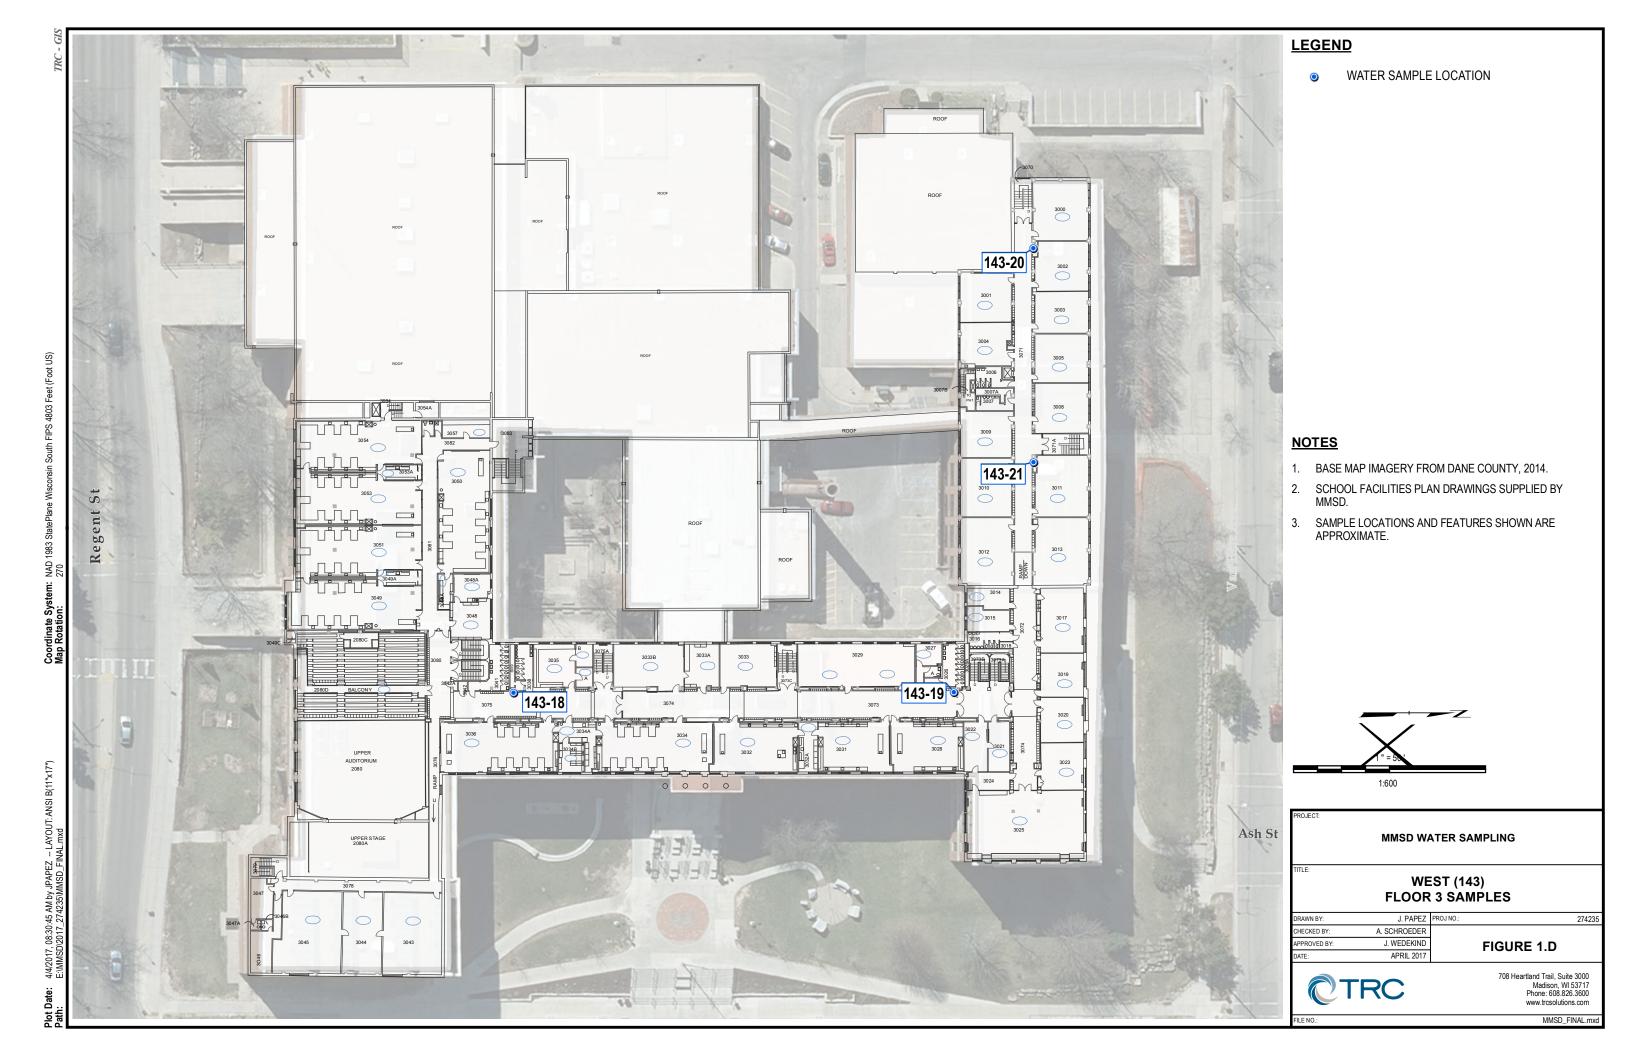
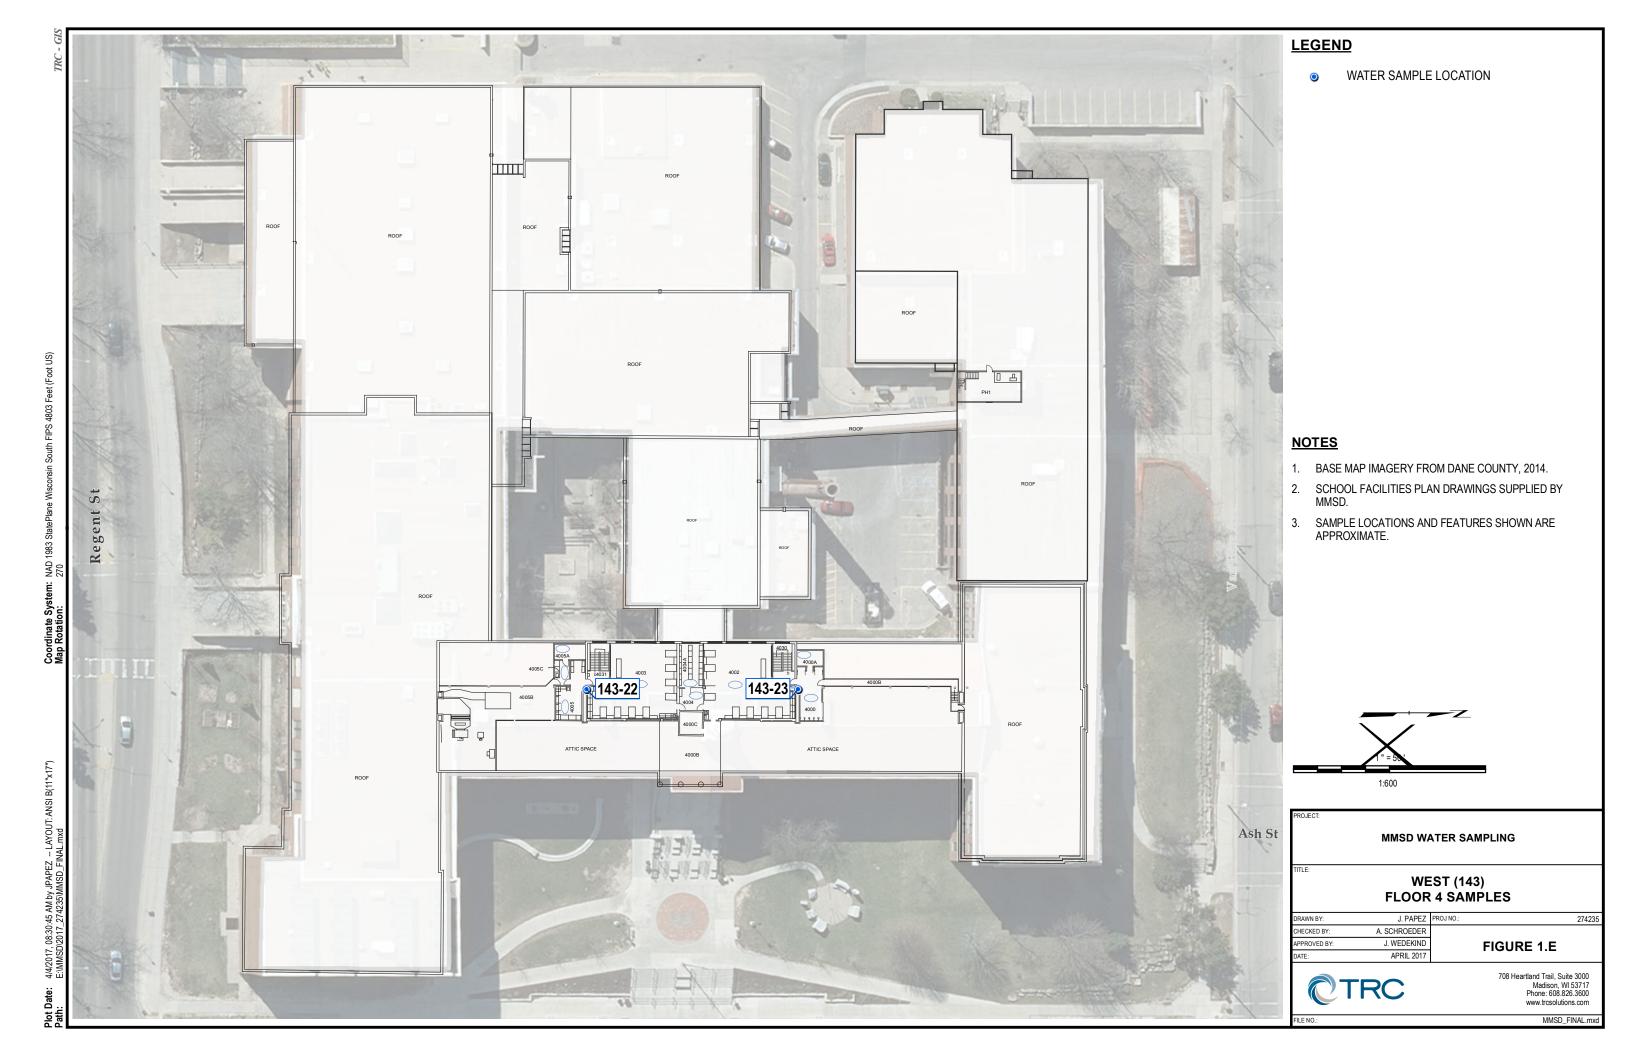
Location Map

Preliminary sample locations were identified by maps provided by MMSD. Following completion of sampling, TRC prepared a map of each school annotated with the final sample locations and identification numbers for each outlet. See Appendix A: Location Map.
